FABRICATION AND TESTING OF A CERAMIC

TWO-CYCLE DIESEL ENGINE

CONTRACT DAAE07-83-C-R05B

DECEMBER 1986

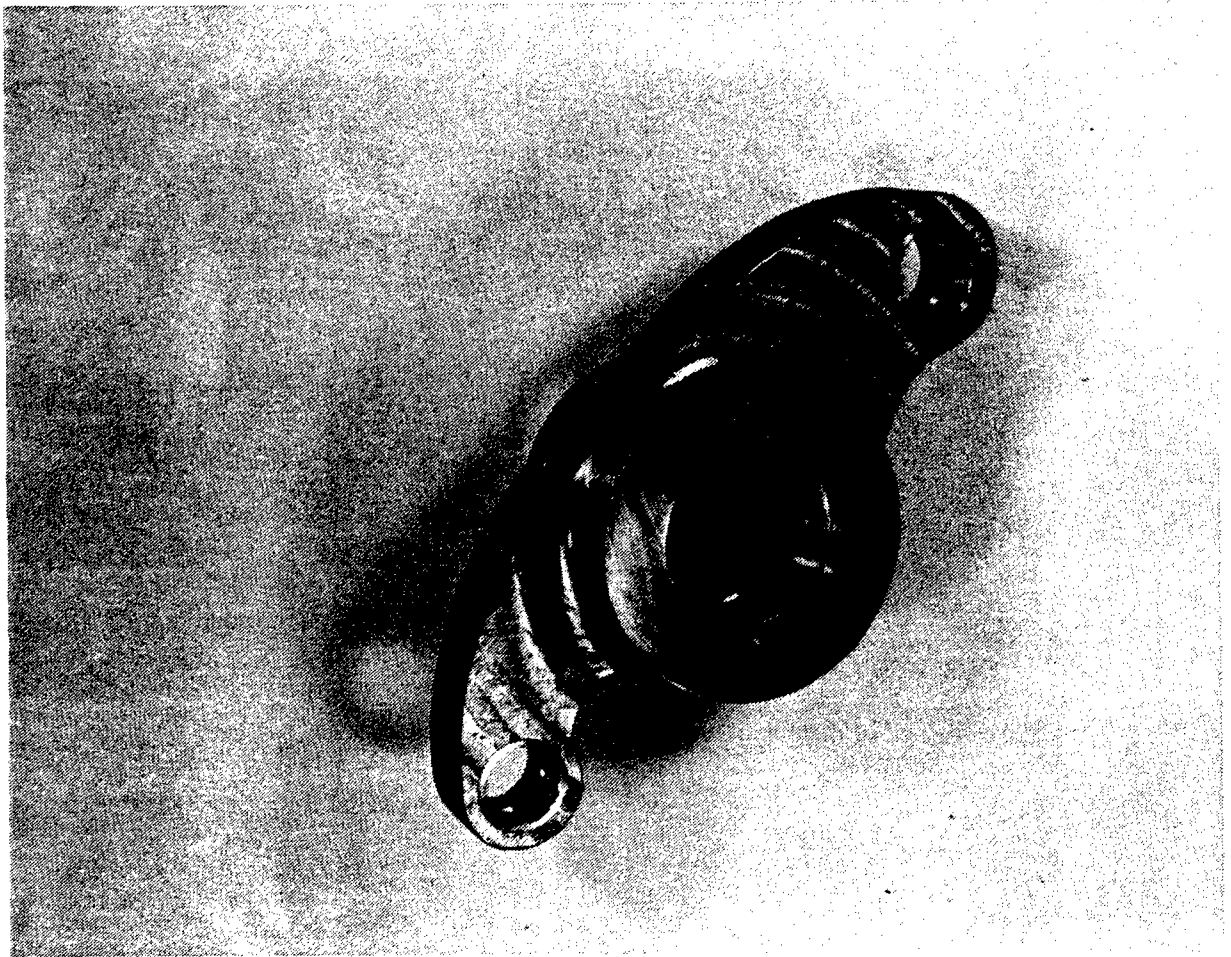
5.5.4. Engine Build B/N-04. A new set of rockers were made from LaSalle stressproof steel (Figure 5-11). New connecting rods were obtained by modifying commercial rods for a 35 HP Volkswagen engine, and welding on a double clevis as shown in Figure 5-12.

Figure 5-11. Steel Rocker Arm (B/N-04)

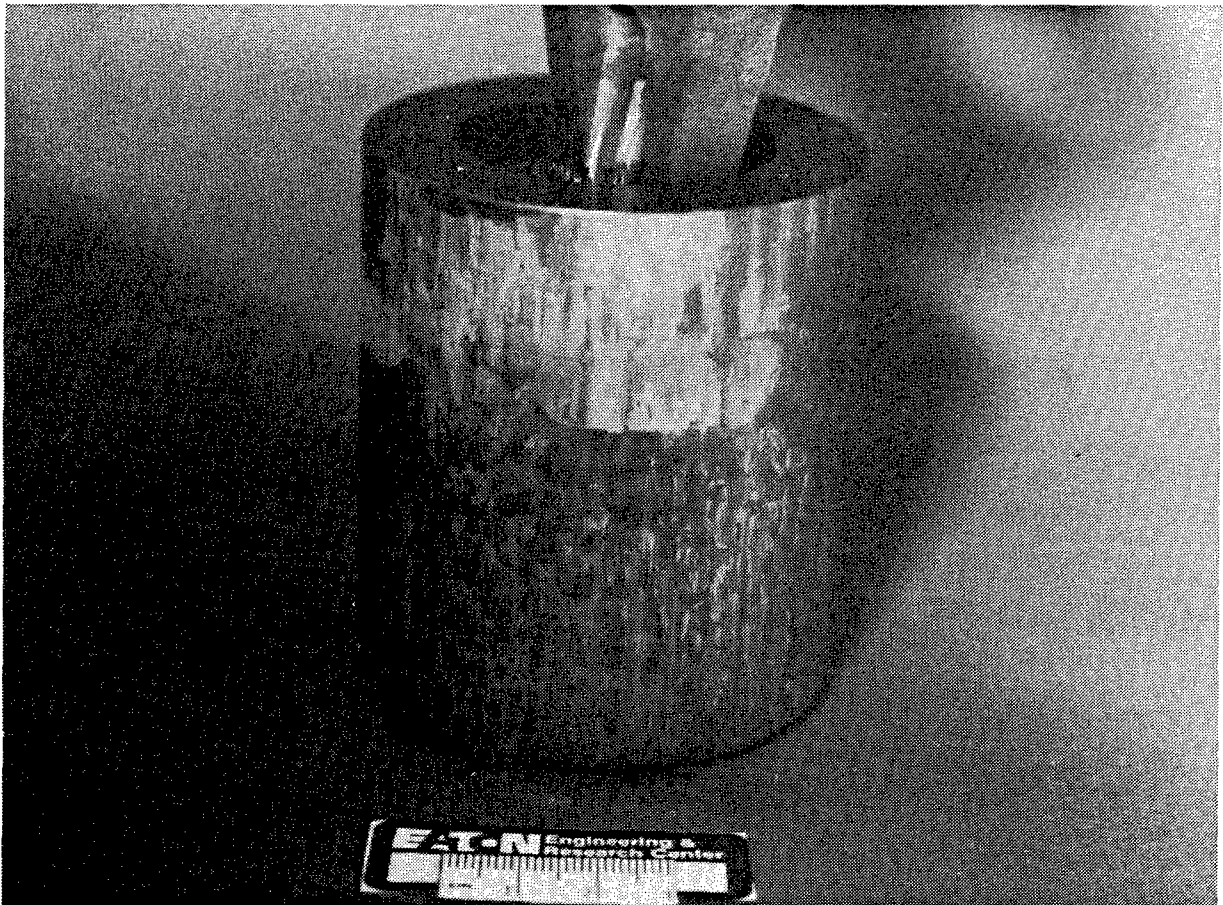
Preliminary engine evaluation was initiated on July 20, 1984. Motoring evaluation at 500-800 rpm resulted in an intermittent "chirping" noise which gradually disappeared after several hours of running. Inspection of the cylinder through the ports revealed some abrasion on the bore. Inspection of the pistons after disassembly showed slight piston abrasion resulting from apparent assembly interference, and wear debris on the skirt which could be easily rubbed off (Figure 5-17).

Figure 5-17. SASC Piston After Motoring (B/N-05)

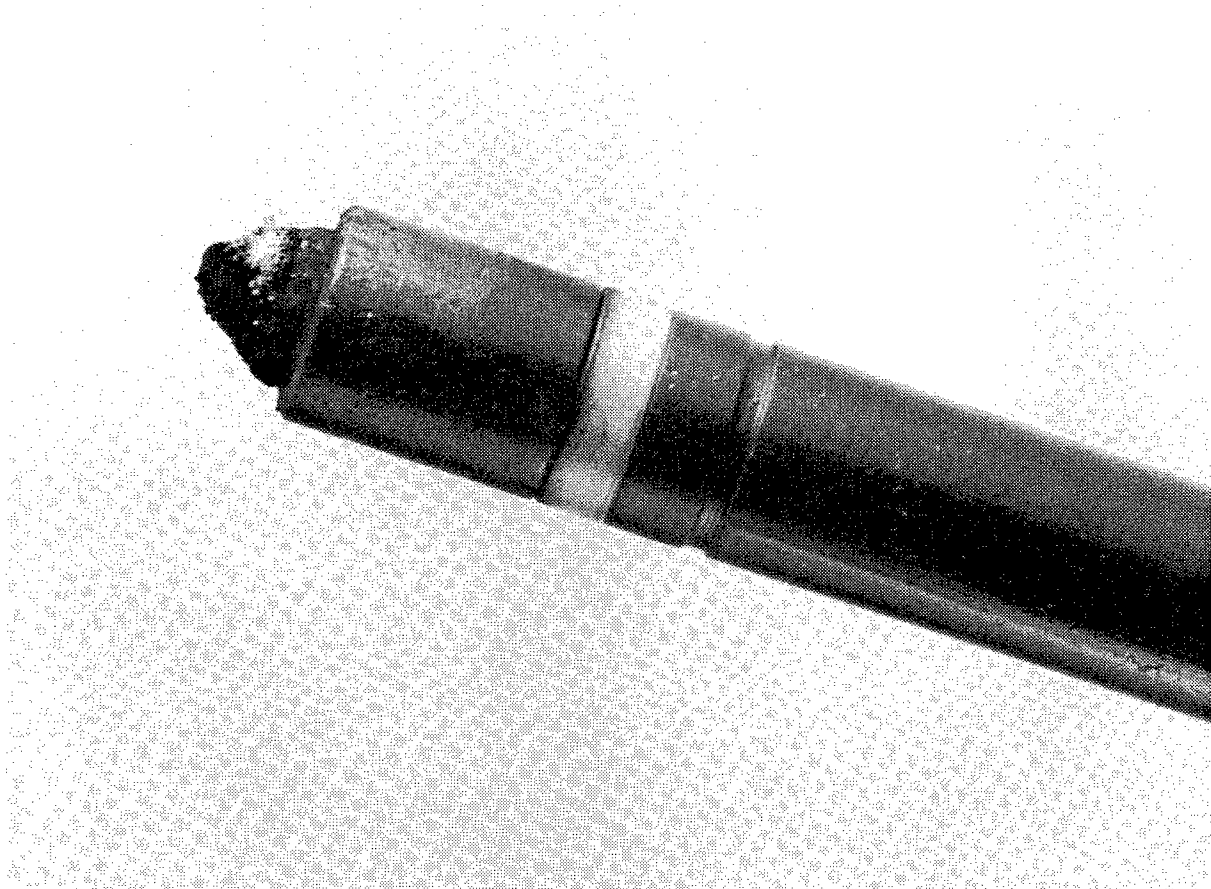
Figure 5-30. Injector Tip with Carbon Deposits
